BRIDGE NO.: 104-1801 STRUCTURE INSPECTION REPORT

BRIDGE NAME: BELMONT BRIDGE

ROUTE NO.: ROUTE 20 / AVON STREET

INSPECTION DATE: SEPTEMBER 2010

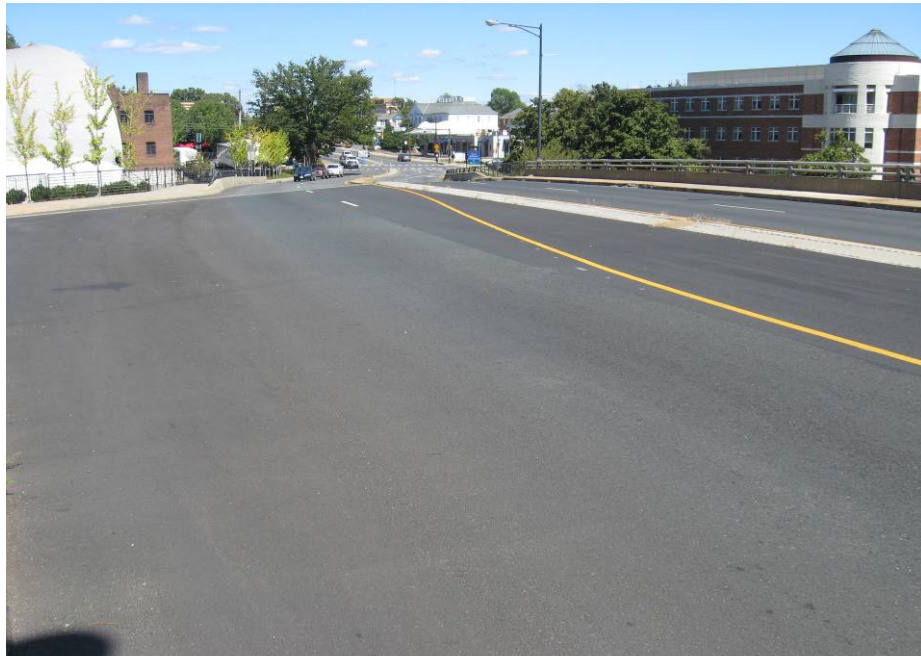
Photo #2

Looking north at SB traffic lanes. New 2" asphalt overlay has been applied.

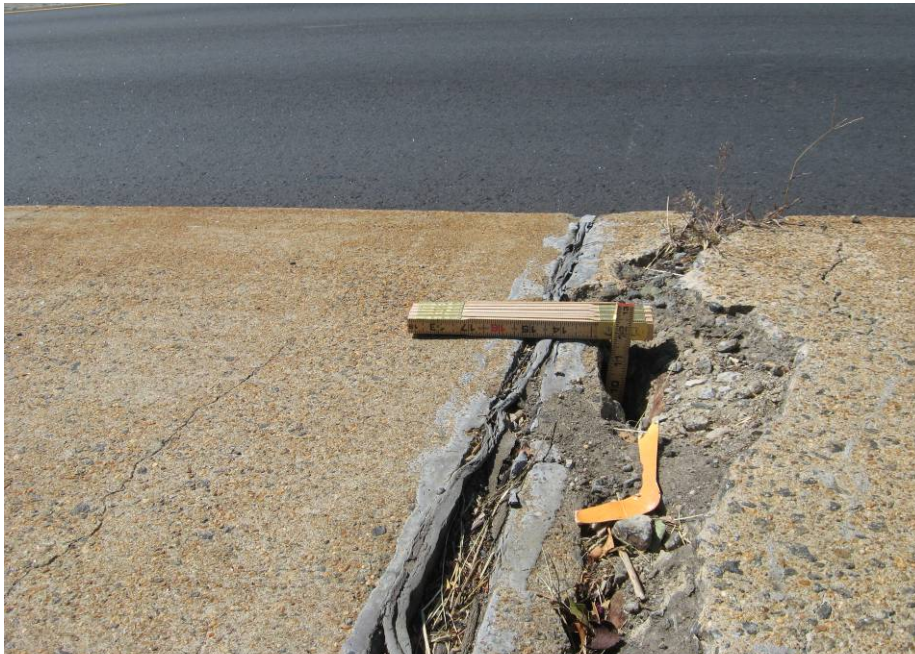
Photo #5

Looking west at sidewalk along NB travel lanes. Sidewalk has spalled completely through deck. Damage is extensive and requires attention. Sidewalk currently poses a tripping hazard to pedestrians.

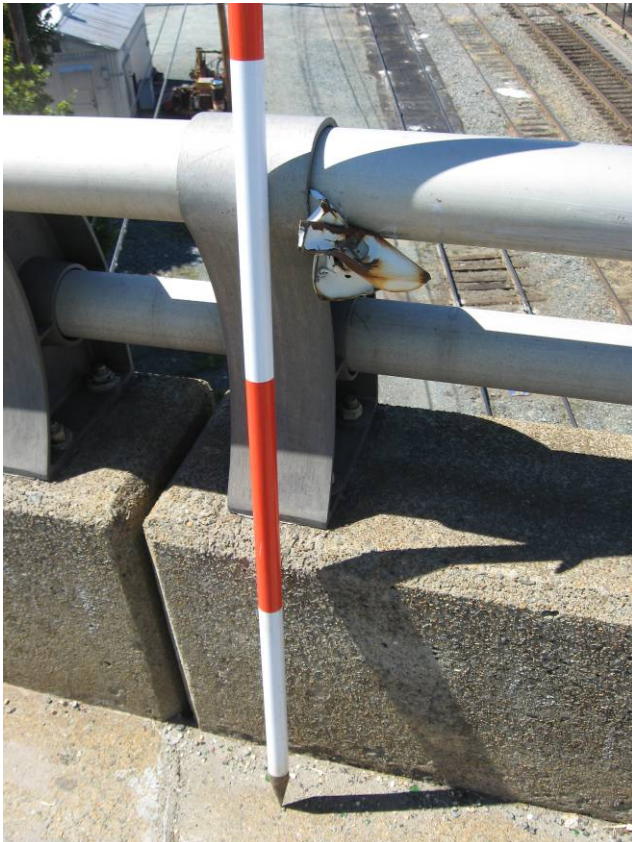
Photo #6

Looking west at railing along SB traffic lanes. Remnants of collision damage remain.

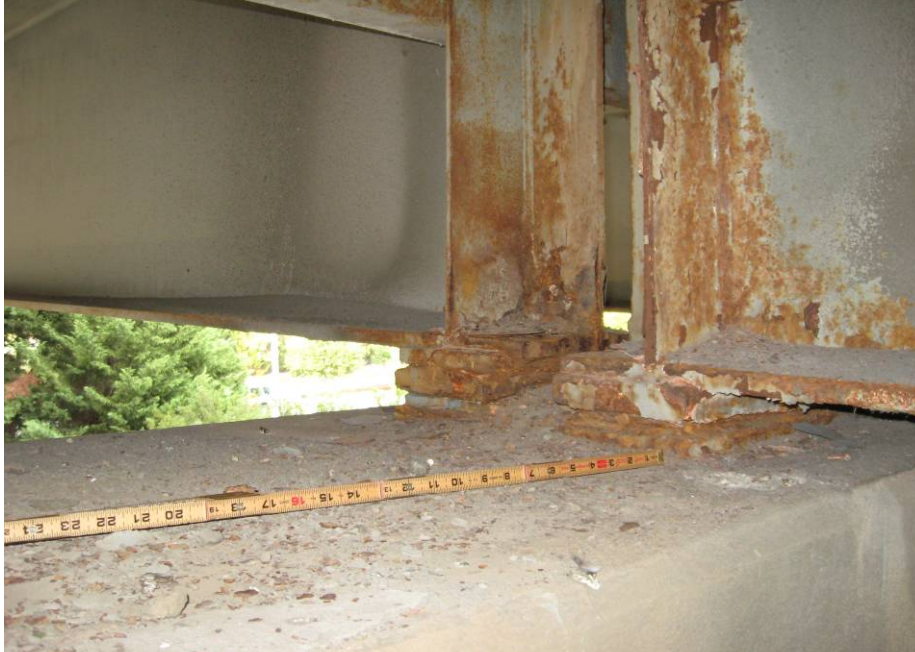
- Areas of surface rust and rust scale typical throughout with up to 1/16" loss of section at isolated locations throughout. Several bearings are covered with a thick overlay of gunite overspray from recent pier cap repairs. See Photo #7

Looking typical beam bearing area rust and section loss.

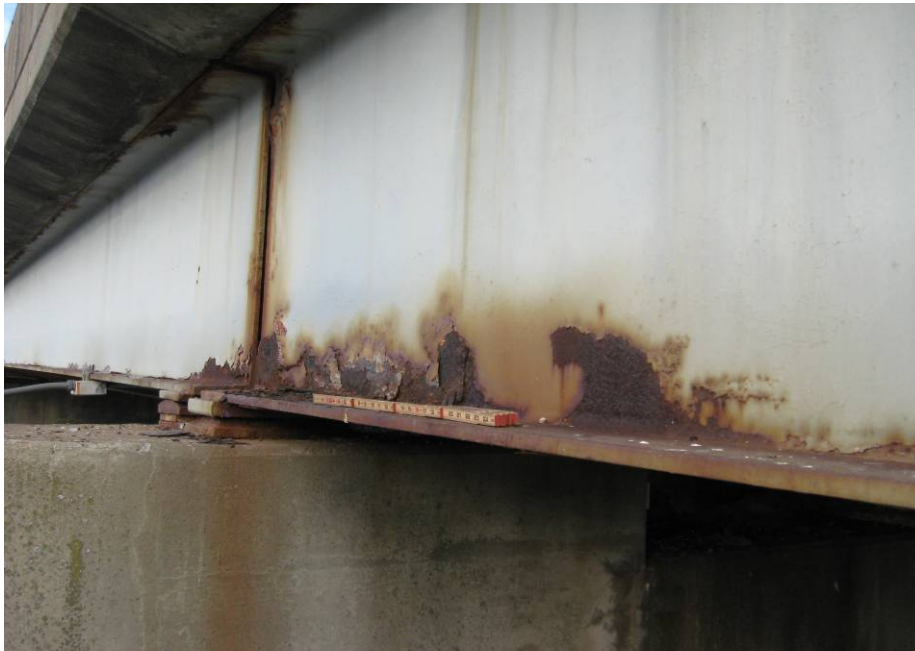
- Steel beam ends have moderate to heavy corrosion and exhibit section loss (0-10%). See Photo #8
- Smoke staining over tracks is accelerating corrosion and specifically bottom flange cover plates and welds show light to moderate corrosion.
- Ends of beams are covered with gunite overspray from previous cap repairs.

Looking north along west face of Beam 1 over Pier 2. Rust and section loss damage is typical throughout.

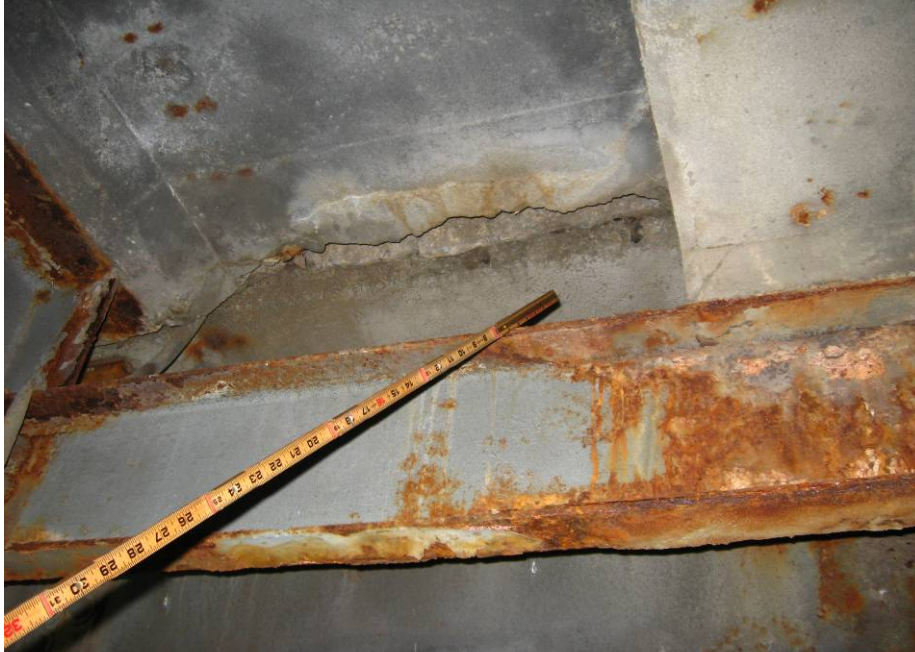
Photo #9

Looking at a typical diaphragm; showing heavy corrosion with minor to moderate section loss up to 1/8" due to leaking construction and expansion joints
